Surface degradation of Siberian larch and Thermally Treated Pine

Hout Bay House Research Project
www.houtbayhouse.info

Preliminary results, research period 3 years

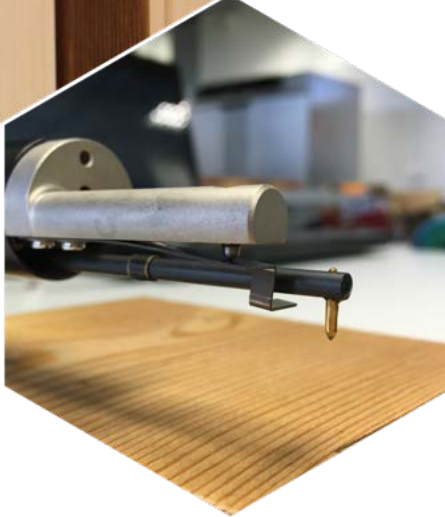
SECA Thermally Treated Pine

The samples are placed on the exterior (facing north in the inclination of 45°) without being covered by roof overhangs. The results show the maximum impact of weathering factors.

*treated with 2 layers of natural oil woodstain UV OSMO
